The Home Inspectors

PROPERTY INSPECTED:

467 Bell St.

September 14, 2015

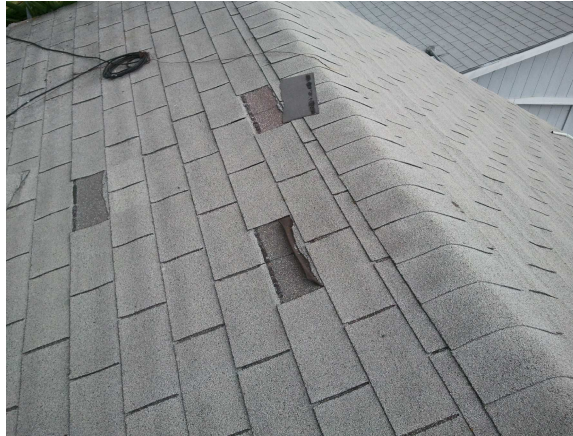
There are some torn and missing shingles.

Recommendation: For further evaluation and repairs contact a licensed roofing contractor ([attention needed](#)).

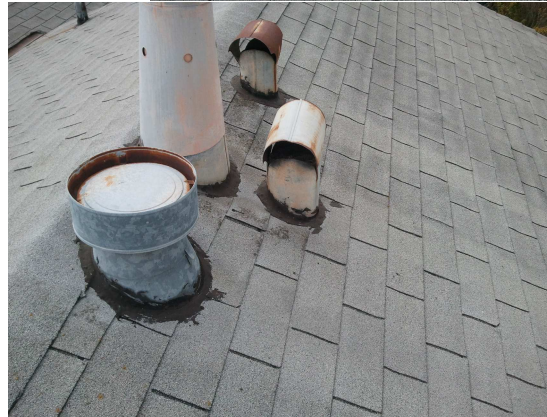
The flashings are not raised to the level of the current roof.

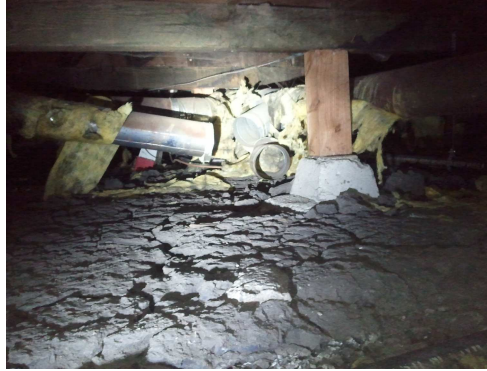
There are distribution ducts apart/open in the crawlspace ([attention needed](#)).

Recommendation: Contact a licensed heating/cooling contractor for repairs/replacement as needed.

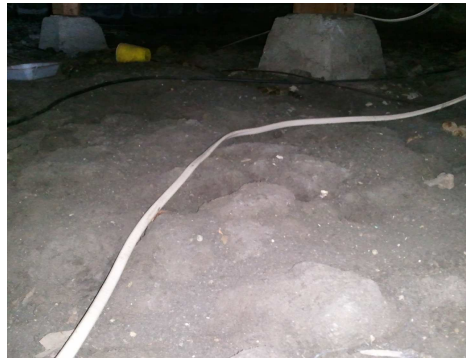
5. There are several unsecured Romex cables on the ground in the crawlspace.

Recommendation: For further evaluation and repair contact a licensed electrician.
