Home Inspection Report

Report Number:
14-04-49JF

Inspection Address:
3900 Lake Mead Drive
Fremont, CA

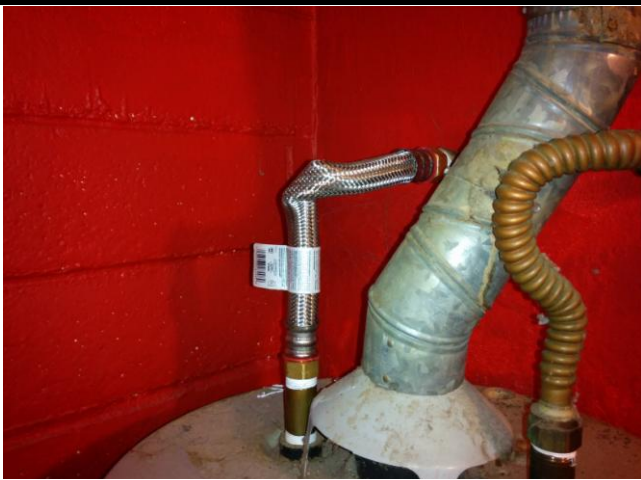
1. **One of the water heater supply hoses was kinked. This can reduce fixture water flow and eventually lead to leakage. The kinked hose should be repaired or replaced. (See Photo 1 in the Inspection Photos section)**

One of the water heater supply hoses was kinked. This can reduce fixture water flow and eventually lead to leakage. The kinked hose should be repaired or replaced.

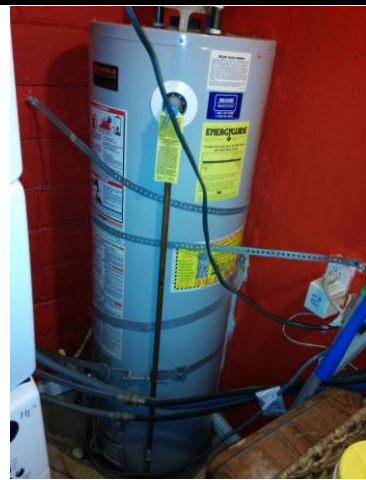
2. **The water heater strap system does not meet the California Division of the State Architect’s published standards, with which all gas fired water heater installations in the state must comply when dwellings are sold or transferred. These standards require at least two restraints on every tank provided by either approved metal strap or electrical conduit. According to these standards, the upper strap shall be located 9” down from the top and the lower strap approximately 4” above the gas control valve. We recommend installation of proper restraint in accordance with current industry standards, local trade practice and the requirements stated above. (See Photo 2 in the Inspection Photos section)**

The water heater strap system does not meet the California Division of the State Architect's published standards, with which all gas fired water heater installations in the state must comply when dwellings are sold or transferred. These standards require at least two restraints on every tank provided by either approved metal strap or electrical conduit. According to these standards, the upper strap shall be located 9" down from the top and the lower strap approximately 4" above the gas control valve. We recommend installation of proper restraint in accordance with current industry standards, local trade practice and the requirements stated above.

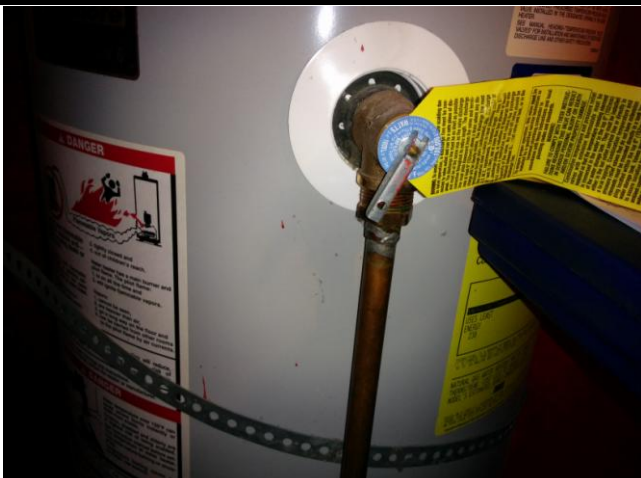
3. **The installation of the temperature and pressure relief valve for the water heater included a discharge pipe smaller than the opening of the valve, a condition that could prove to be dangerous. A discharge pipe conforming to the relief valve manufacturer’s specifications and local requirements should be installed so as to exit at an approved location. For safety, the temperature and pressure relief valve discharge pipe should be a rigid copper or steel pipe, not threaded on the outlet end, of the same diameter as the outlet port of the valve. (See Photo 3 in the Inspection Photos section)**

The installation of the temperature and pressure relief valve for the water heater included a discharge pipe smaller than the opening of the valve, a condition that could prove to be dangerous. A discharge pipe conforming to the relief valve manufacturer's specifications and local requirements should be installed so as to exit at an approved location. For safety, the temperature and pressure relief valve discharge pipe should be a rigid copper or steel pipe, not threaded on the outlet end, of the same diameter as the outlet port of the valve.

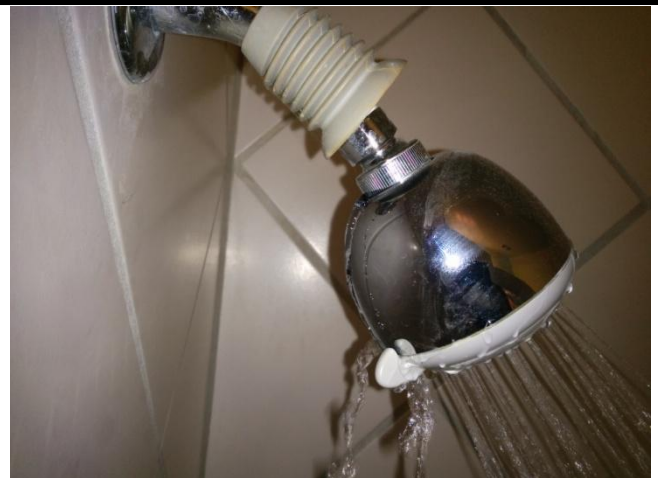
5. **The drain stop for the tub in the hall bath was not operational. The drain stop for the bathtub should be repaired or replaced.**
6. **The showerhead was leaking in the hall bath. The leak may put water behind finished surfaces or outside the tub. All leaks from the showerhead that might put water behind finished surfaces should be repaired. (See Photo 4 in the Inspection Photos section)**

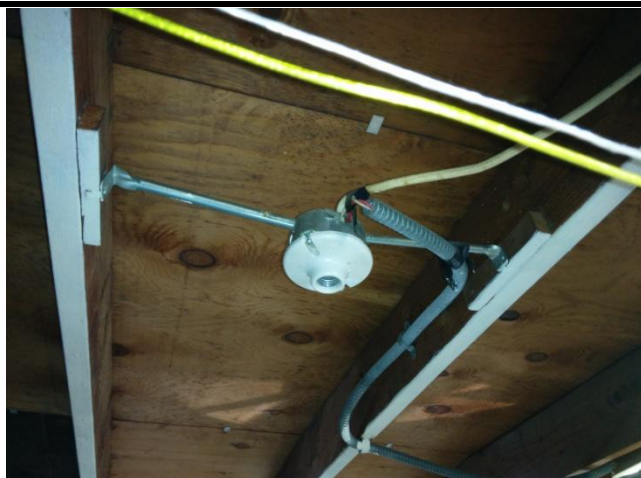
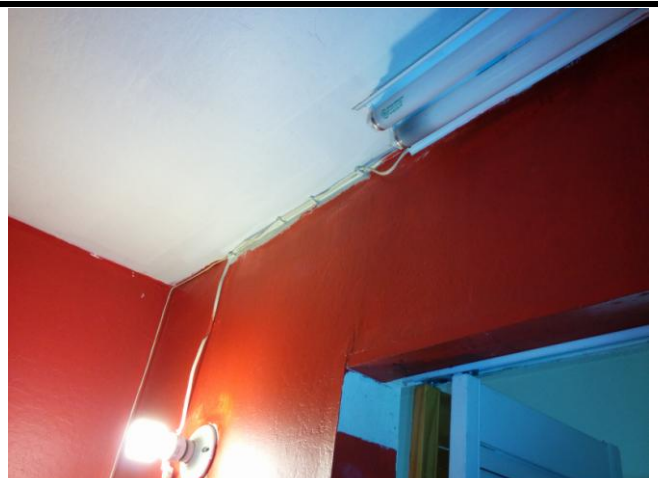
8. **Improper wiring techniques and methods were observed in the garage and in the laundry area. Improperly installed wiring should be removed and replaced with new wiring installed in conformance with standard trade practices by a competent, licensed electrician. (See Photos 5 and 6 in the Inspection Photos section)**

Improper wiring techniques and methods were observed in the garage and in the laundry area. Improperly installed wiring should be removed and replaced with new wiring installed in conformance with standard trade practices by a competent, licensed electrician.

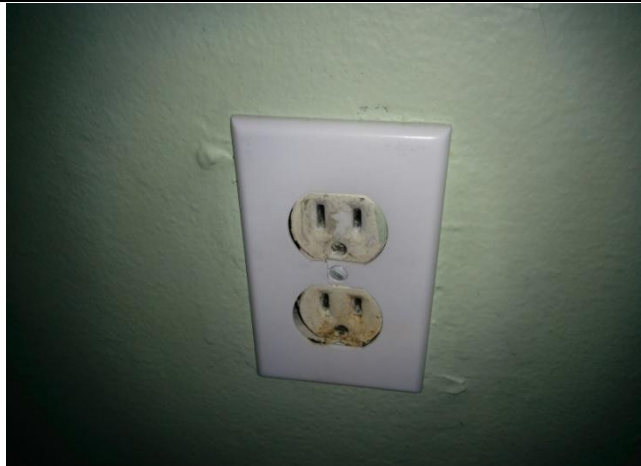
9. A receptacle cover in the master bedroom did not fit properly, resulting in gaps and creating a potential shock hazard. We recommend replacement with a properly sized cover. (See Photo 7 in the Inspection Photos section)
10. The light fixture in the middle bedroom was loose. The fixture should be resecured or replaced. (See Photo 8 in the Inspection Photos section)

A receptacle cover in the master bedroom did not fit properly, resulting in gaps and creating a potential shock hazard. We recommend replacement with a properly sized cover.

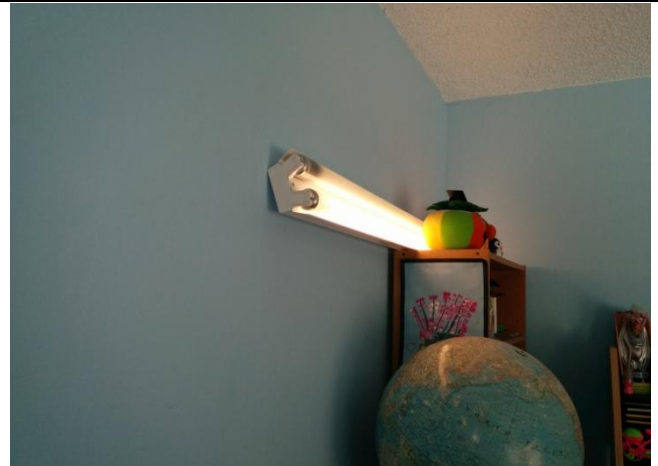
Photo 8

The light fixture in the middle bedroom was loose. The fixture should be resecured or replaced.

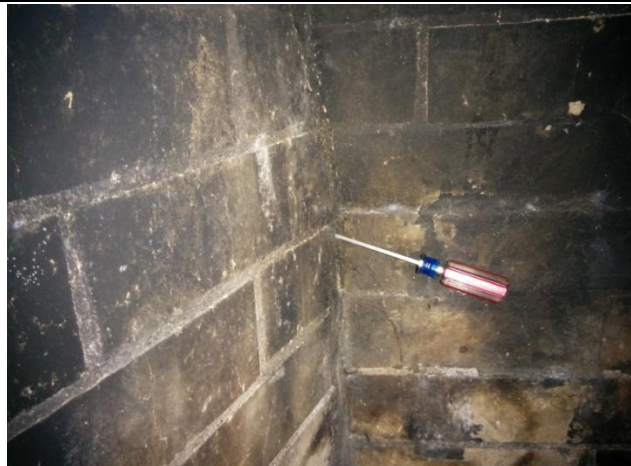
11. There were gaps in the fireplace walls creating a fire hazard. We recommend consulting a licensed fireplace contractor for further evaluation and repair as necessary. (See Photo 9 in the Inspection Photos section)

There were gaps in the fireplace walls creating a fire hazard. We recommend consulting a licensed fireplace contractor for further evaluation and repair as necessary.

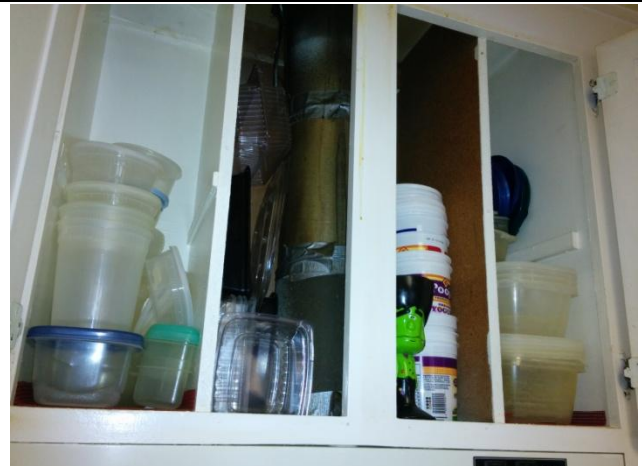
14. The kitchen exhaust vent pipe had no cover. We recommend that a cover be installed to keep combustible materials away from the pipe and to protect any electrical wiring which may be inside the enclosure. (See Photo 10 in the Inspection Photos section)

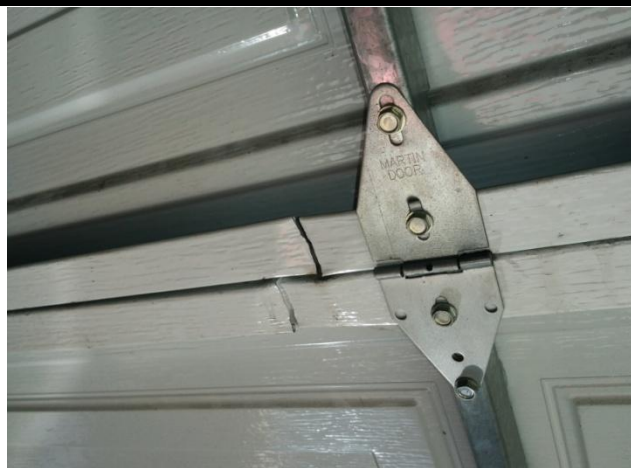
15. The garage door was damaged, exposing it to accelerated weathering and affecting its performance. The damaged door should be repaired, or a replacement door should be installed in conformance with standard trade practices. (See Photo 11 in the Inspection Photos section)

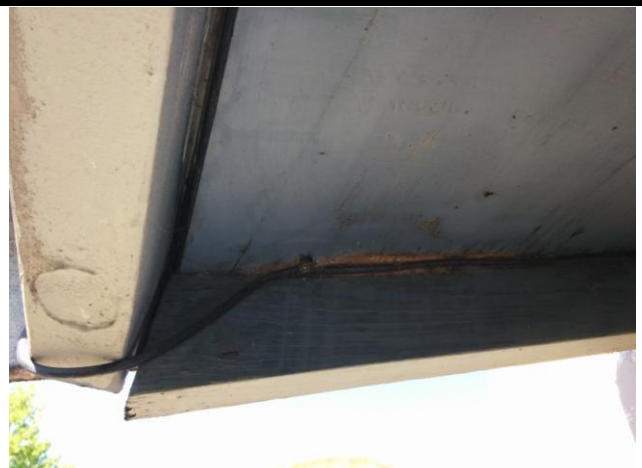
16. Although the areas normally considered common areas (the exterior, roof, attic, crawlspace and grounds) are not included in this report, there were obvious symptoms of wood destroying pest and/or organism activity in the eaves at the left front corner. We recommend consultation with a licensed pest control operator. (See Photo 12 in the Inspection Photos section)
